HURRICANE KATE STORM SURGE DATA

Report 5

Coastal Engineering Research Center

August 1987

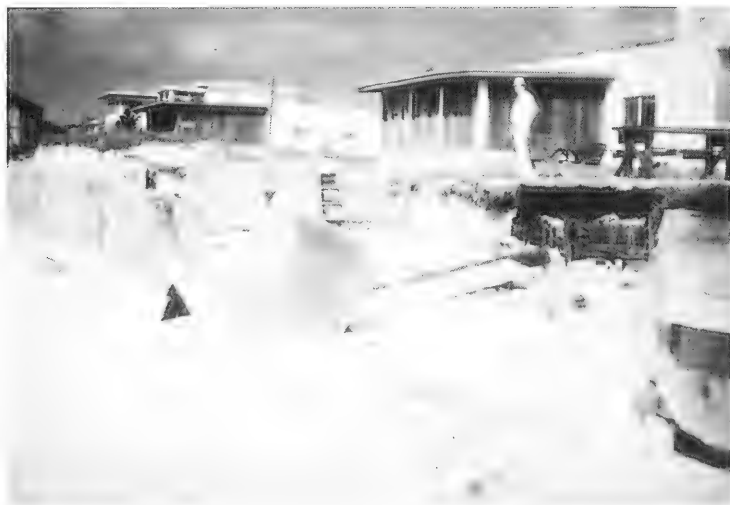
14. At Mexico Beach, the erosion was more severe, uncovering and destroying a seawall (Photo 2) that had been completely buried by a sand dune prior to the hurricane. Surge elevations estimated at this location from the watermark on the side of the canal on the west end of town (Photo 3) were approximately 7 ft. Wind damage in this area was relatively minor.

Photo 2. Destroyed seawall, Mexico Beach, Fla.

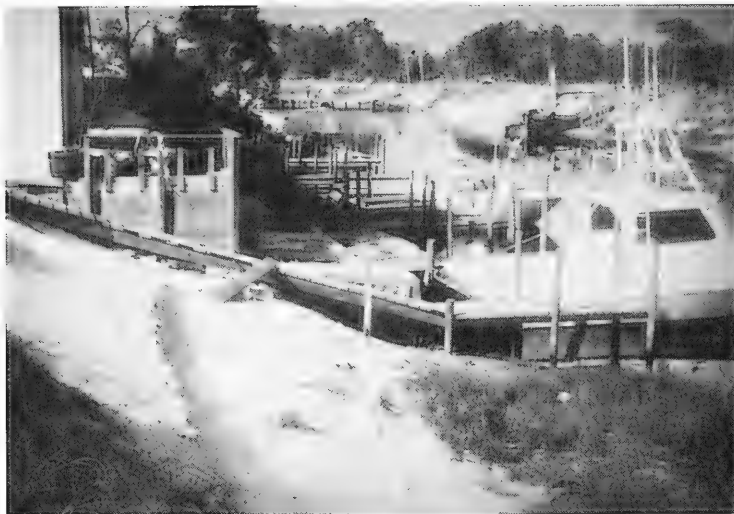
Photo 3. High-water mark, Mexico Beach, Fla.

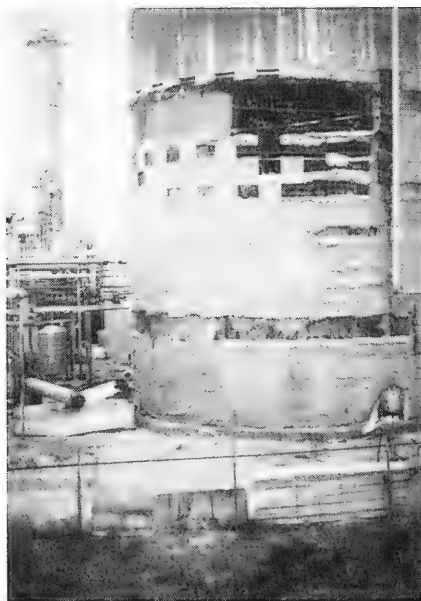
15. The extent of wind damage increased rapidly farther east; an example can be seen by the stripped siding and insulation on a storage tank at the paper company in Port St. Joe (Photo 4). However, the amount of surge damage in Port St. Joe was minimal due to the excellent protection offered by the St. Joseph spit offshore. The spit itself suffered massive erosion, as can be seen by the scarp cut into the duneline at the St. Joseph Peninsula State Park (Photo 5). The combined surge and wave runup at this location exceeded +16 ft.

Photo 4. Damaged tank covering, Port
St. Joe, Fla.

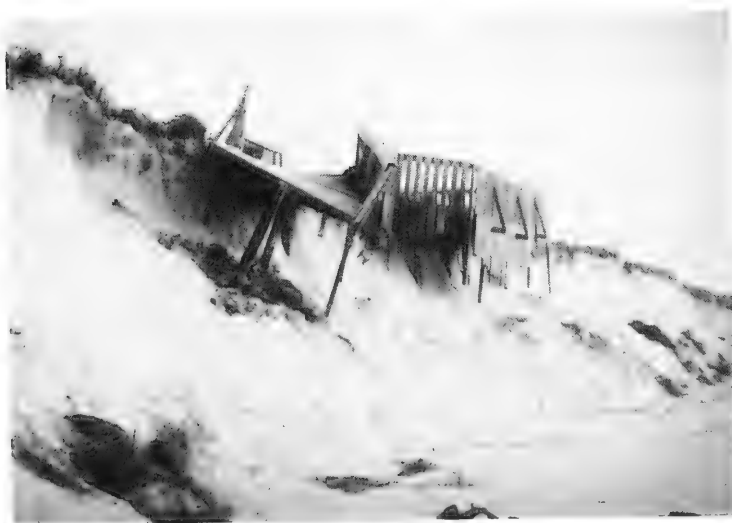
16. Property damage within the park was confined to boardwalks (Photo 6) due to the lack of construction along the beachfront. Farther south at Cape San Blas, there was more extensive damage. Several homes were totally destroyed (Photo 7), and houses that survived were undermined by beach erosion (Photo 8). The surge elevation at this location was approximately at 9 ft. Many of the buildings located far enough from the beach to be protected from surge damage suffered wind damage (Photo 9).

Photo 6. Damaged boardwalk, St. Joseph Peninsula State Park, Fla.

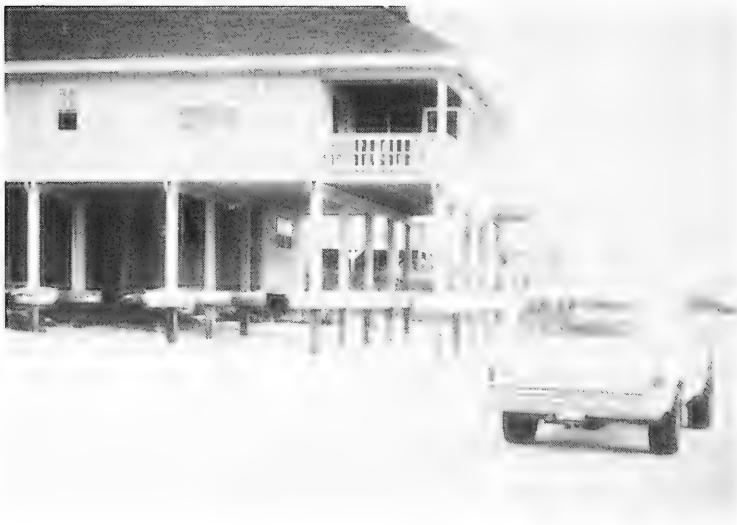
Photo 8. Beach erosion under house, Cape San Blas, Fla.

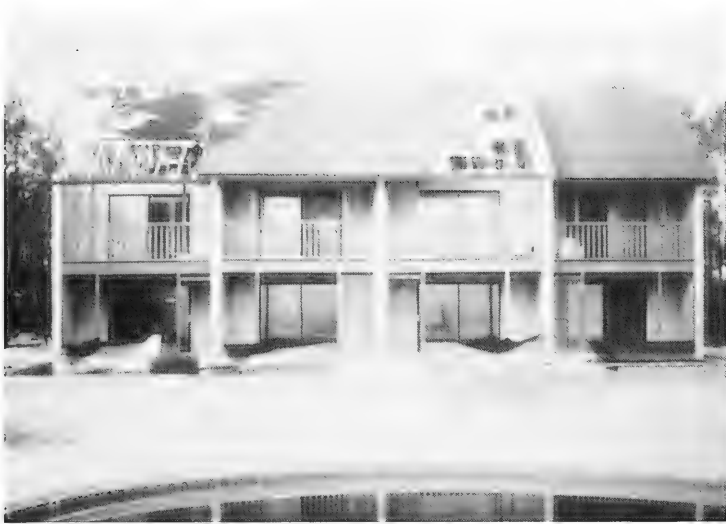
Photo 9. Roof damage, Cape San Blas, Fla.

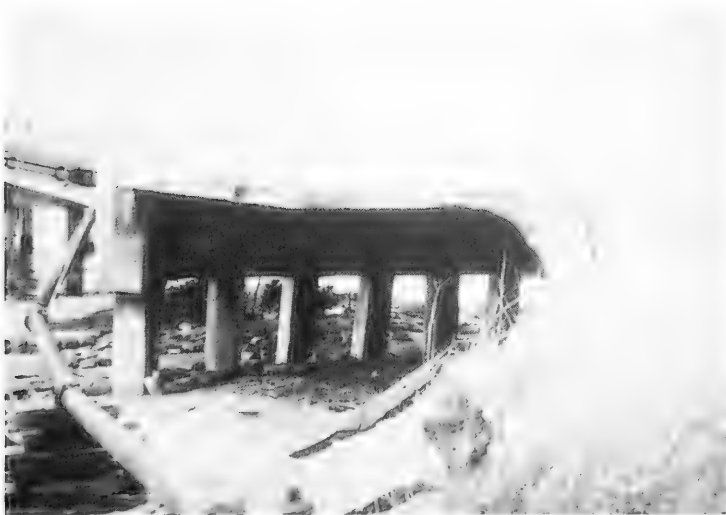
17. An attempt was made to survey St. George Island; however, surge-induced flooding had undermined the approach ramp at the mainland end of the

bridge to the island, cutting off all vehicular access (Photo 10). Damage was significant on the protected mainland coast behind the island. Several miles of Highway 98 along the coast between Cape San Blas and Carrabelle were undermined and had collapsed (Photos 11 and 12). The Hut Restaurant in Apalachicola was completely destroyed (Photo 13). Between East Point and Carrabelle, several homes and trailers located on waterfront lots were totally destroyed (Photos 14 and 15). Farther east, at Lighthouse Point, there was more destruction (Photo 16). Throughout this area, surge elevations were approximately 7 ft. Wind and surge damage, although less severe, was reported as far east as Cedar Key, Fla.

Photo 10. Highway damage, St. George Island Bridge, Fla.

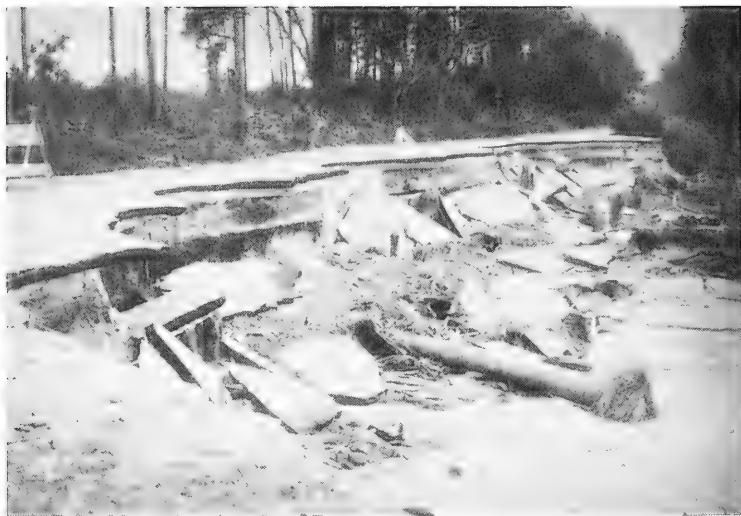
Photo 11. Highway damage between Cape San Blas and Carrabelle, Fla.

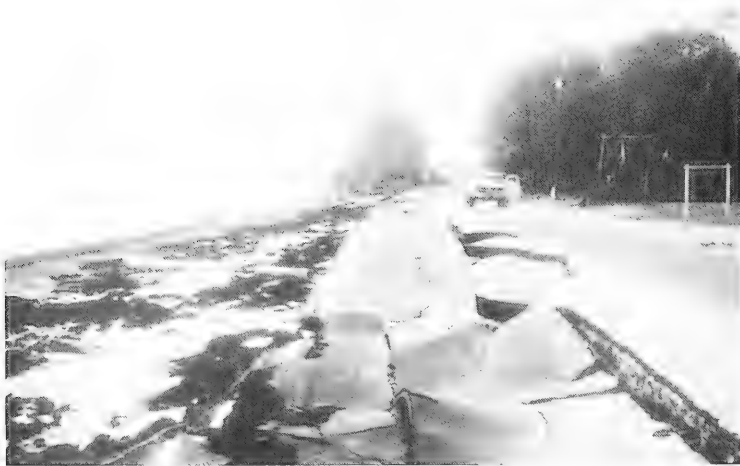
Photo 12. Highway damage near Carrabelle, Fla.

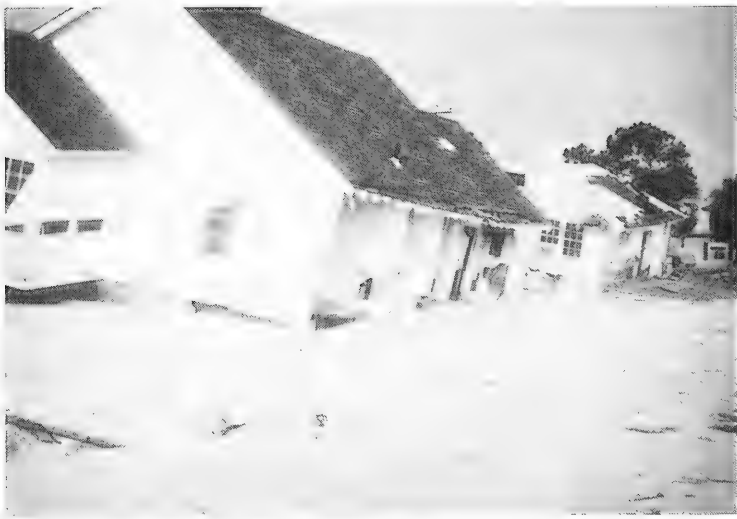
Photo 16. House destruction, Lighthouse Point, Fla.
